# HAZARDOUS MATERIALS SURVEY REPORT

May 28, 2019

Science South Building  
Montgomery College – Takoma Park  
7600 Takoma Avenue  
Takoma Park, Maryland 20912

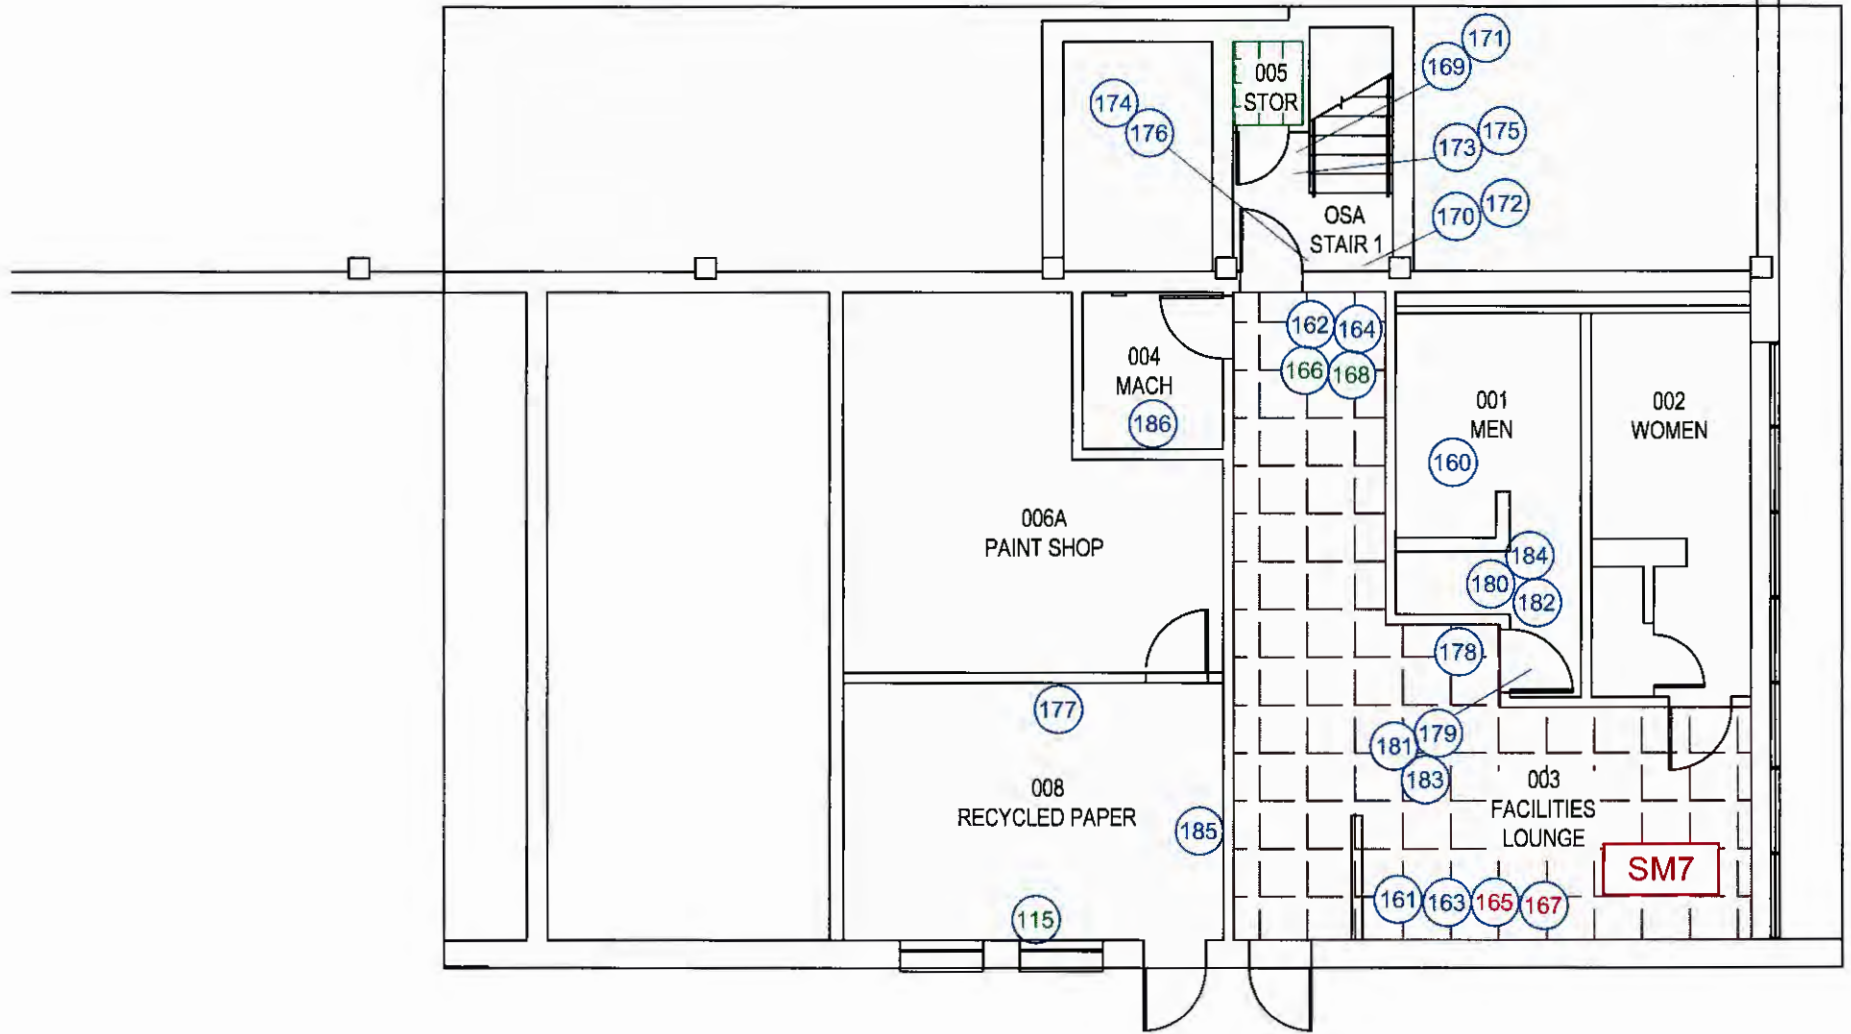
FIGURE 1  
ASBESTOS SURVEY

THE ASBESTOS-CONTAINING CREAM SEAM MASTIC ON WHITE, BLACK, AND TAN PAPER FOIL WRAPPED FIBERGLASS INSULATED PIPES WERE OBSERVED THROUGHOUT THE BUILDING.

THE ASBESTOS-CONTAINING INTERIOR AND EXTERIOR WINDOW CAULKS WERE OBSERVED THROUGHOUT THE WINDOWS OF THE BUILDING.

THE ASBESTOS-CONTAINING INTERIOR AND EXTERIOR WINDOW GLAZINGS WERE OBSERVED THROUGHOUT THE WINDOWS OF THE BUILDING.

ADHESIVE BEHIND WHITEBOARD WAS SAMPLED BY THE CLIENT AND IDENTIFIED AS ASBESTOS-CONTAINING MATERIAL. THIS MATERIAL WAS OBSERVED THROUGHOUT THE CLASSROOMS.

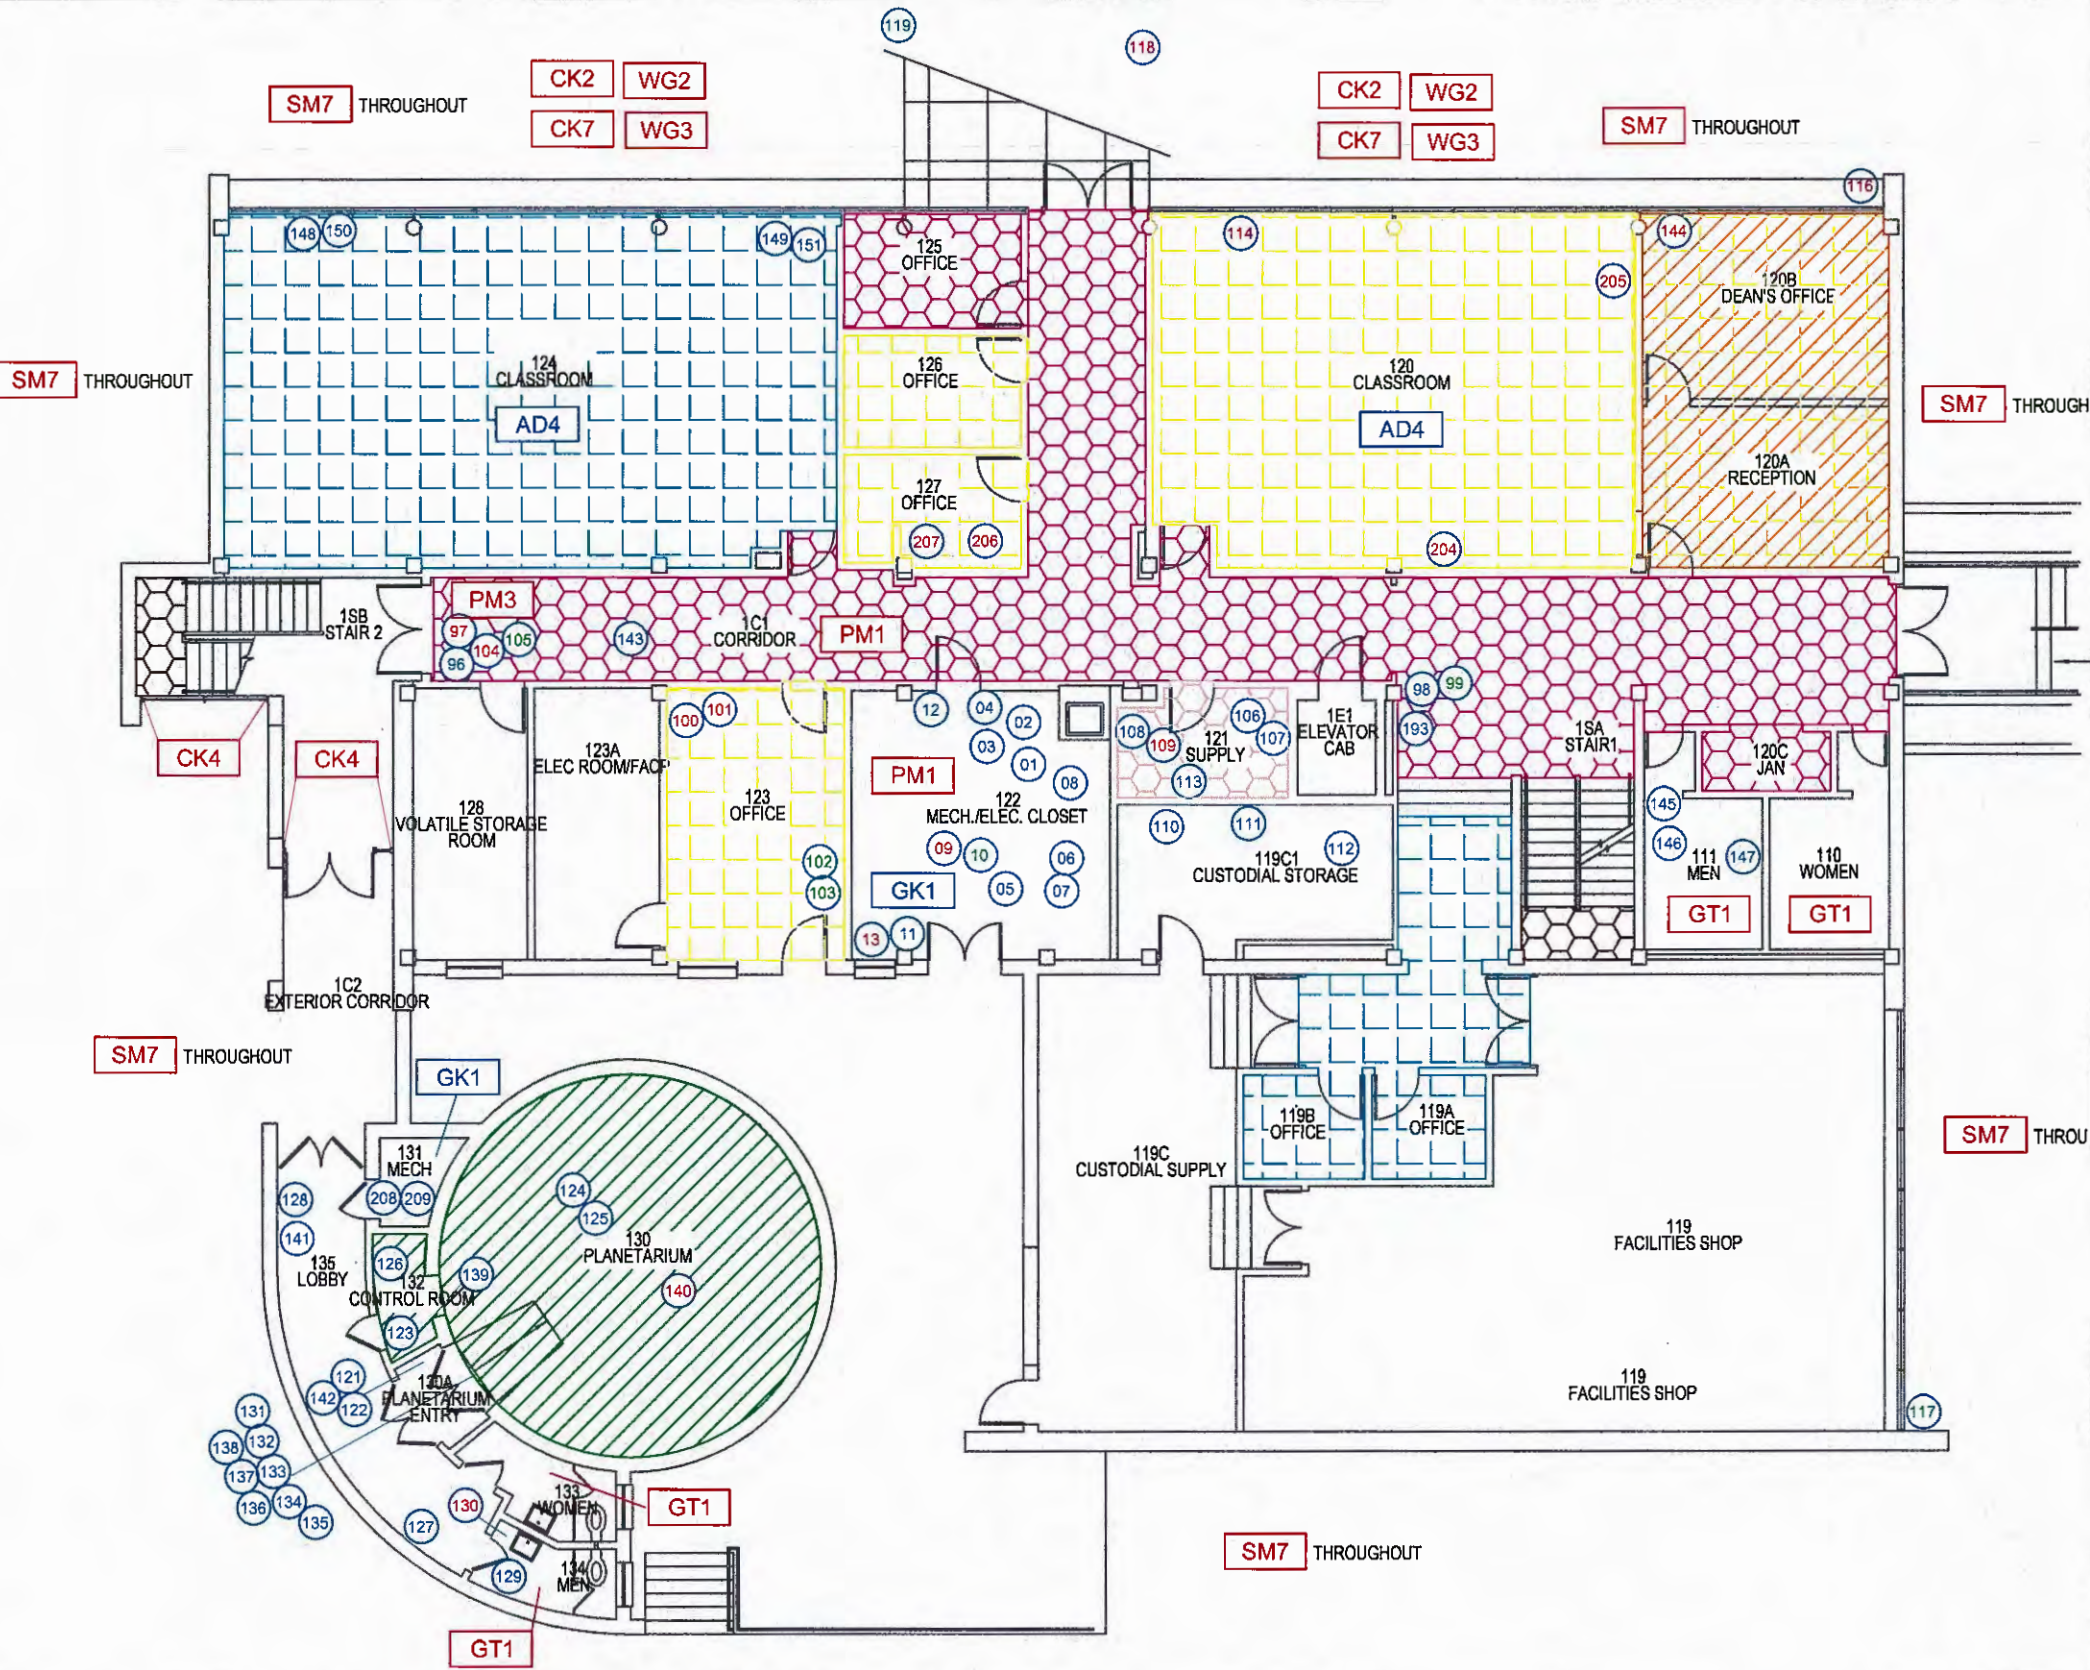
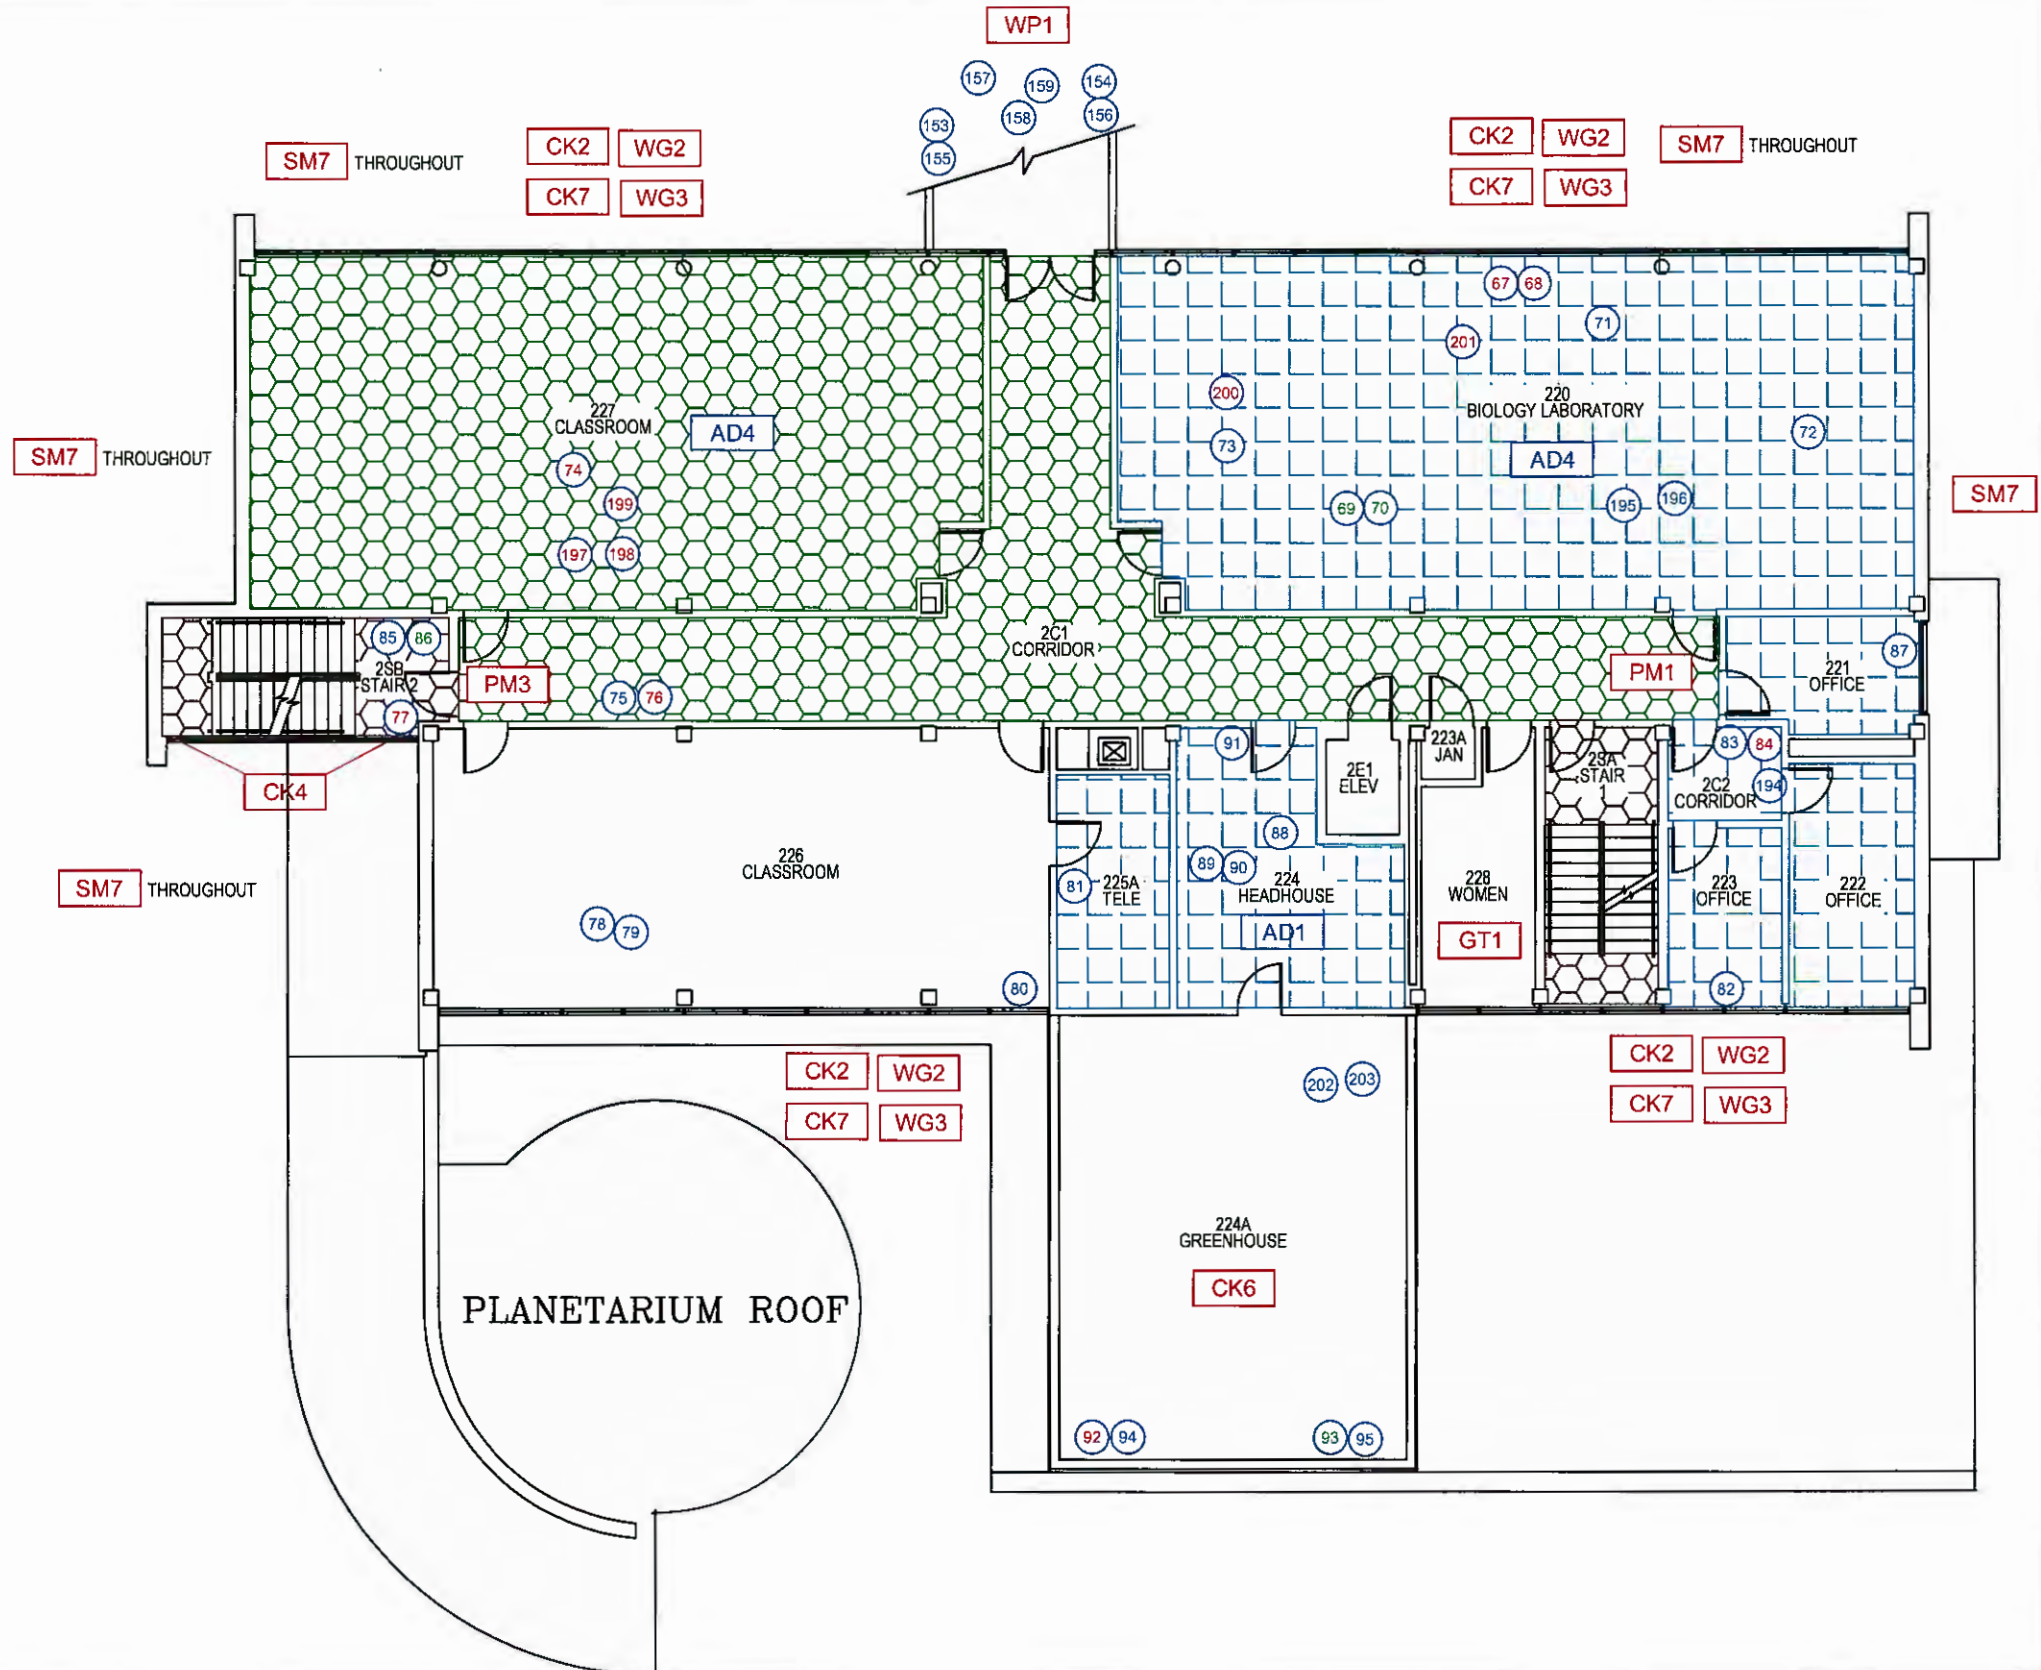
FIGURE 1  
ASBESTOS SURVEY

- SM7** THE ASBESTOS-CONTAINING CREAM SEAM MASTIC ON WHITE, BLACK, AND TAN PAPER FOIL WRAPPED FIBERGLASS INSULATED PIPES WERE OBSERVED THROUGHOUT THE BUILDING

- CK2** THE ASBESTOS-CONTAINING INTERIOR AND EXTERIOR WINDOW CAULKS WERE OBSERVED THROUGHOUT THE WINDOWS OF THE BUILDING
  - CK7** THE ASBESTOS-CONTAINING INTERIOR AND EXTERIOR WINDOW GLAZINGS WERE OBSERVED THROUGHOUT THE WINDOWS OF THE BUILDING

- WG2** THE ASBESTOS-CONTAINING INTERIOR AND EXTERIOR WINDOW GLAZINGS WERE OBSERVED THROUGHOUT THE WINDOWS OF THE BUILDING
  - WG3** THE ASBESTOS-CONTAINING INTERIOR AND EXTERIOR WINDOW GLAZINGS WERE OBSERVED THROUGHOUT THE WINDOWS OF THE BUILDING

- AD4** ADHESIVE BEHIND WHITEBOARD WAS SAMPLED BY THE CLIENT AND IDENTIFIED AS ASBESTOS-CONTAINING MATERIAL. THIS MATERIAL WAS OBSERVED THROUGHOUT THE CLASSROOMS

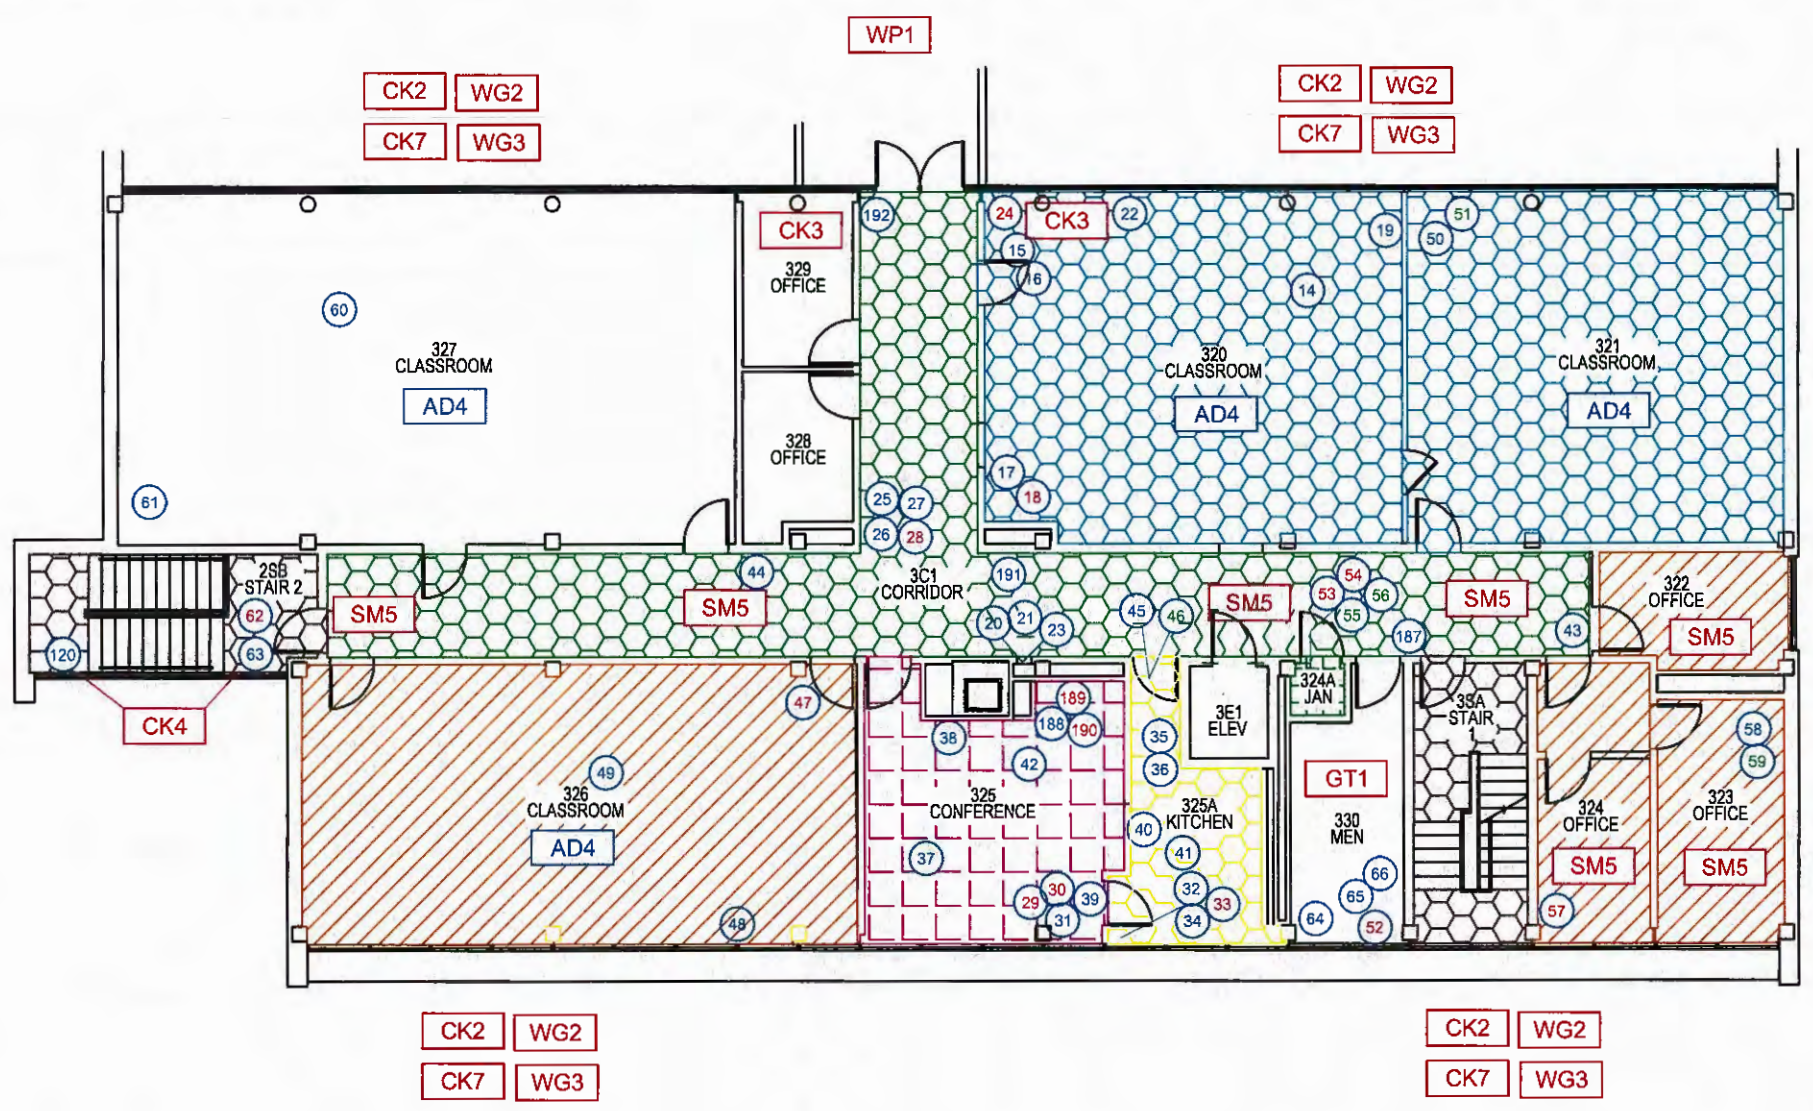
FIGURE 1  
ASBESTOS SURVEY

- ALL FIRE DOORS WHERE PRESENT, ARE ASSUMED TO BE ASBESTOS-CONTAINING AND WERE NOT SAMPLED. ALL RATED FIRE DOORS THROUGHOUT THE BUILDING SHOULD BE TREATED AS ASBESTOS-CONTAINING UNTIL SAMPLING DETERMINES OTHERWISE.
- SM7** THE ASBESTOS-CONTAINING CREAM SEAM MASTIC ON WHITE, BLACK, AND TAN PAPER FOIL WRAPPED FIBERGLASS INSULATED PIPES WERE OBSERVED THROUGHOUT THE BUILDING.
- CK2** THE ASBESTOS-CONTAINING INTERIOR AND EXTERIOR WINDOW CAULKS WERE OBSERVED THROUGHOUT THE WINDOWS OF THE BUILDING.
- CK7**
- WG2** THE ASBESTOS-CONTAINING INTERIOR AND EXTERIOR WINDOW GLAZINGS WERE OBSERVED THROUGHOUT THE WINDOWS OF THE BUILDING.
- WG3**
- AD4** ADHESIVE BEHIND WHITEBOARD WAS SAMPLED BY THE CLIENT AND IDENTIFIED AS ASBESTOS-CONTAINING MATERIAL. THIS MATERIAL WAS OBSERVED THROUGHOUT THE CLASSROOMS.
